AVIONICS DESIGN SERVICES LTD.
ENGINEERING ORDER

NUMBER: EO13015-7

INSTALLATION INSTRUCTIONS FOR THE TECHNISONIC DIGITAL AUDIO SPLITTER
(BELL 206)

The purpose of this Engineering Order is to provide instructions for the installation and activation of a Technisonic DAS-9000 Digital Audio Splitter.

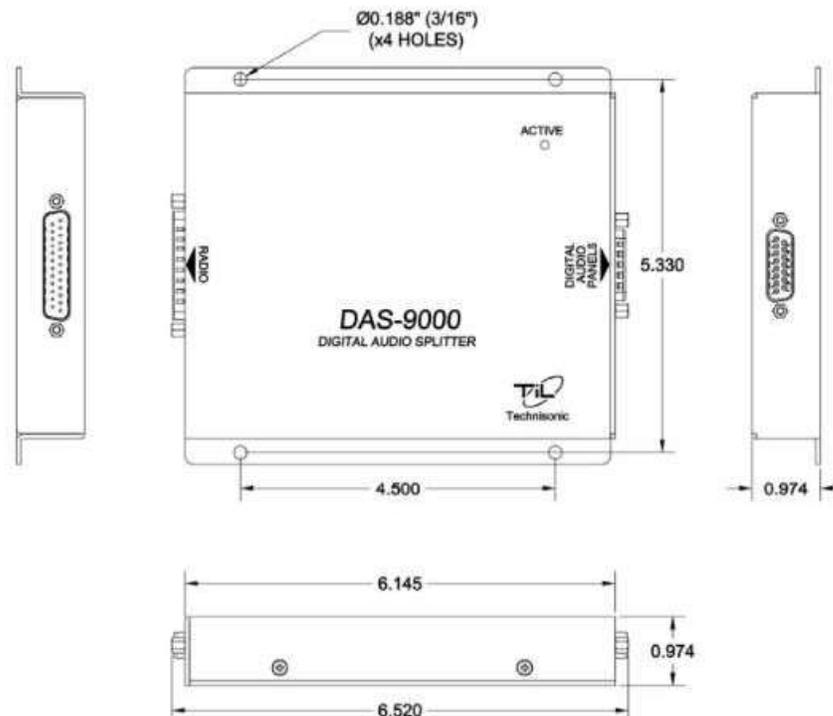
Figure 1 - DAS-9000 Installation Footprint

1. The DAS-9000 Digital Audio Splitter (P/N: 241309-1) must be installed on either the rotorcraft's secondary or tertiary structure, in a location close to its applicable TDFM-9000 series transceiver. The footprint of the DAS-9000 is provided below in Figure 1 for reference.

2. If a mounting plate/ bracket is used, fabricate using appropriate materials to suit the chosen installation location, in accordance with standard practices. Secure the DAS-9000 to the plate/ bracket using four sets of appropriately-sized standard aviation grade fasteners. The plate/ bracket assembly must then be installed onto the rotorcraft secondary or tertiary structure using standard aviation grade mounting hardware.

3. If no mounting plate/ bracket is used, install the DAS-9000 directly onto the rotorcraft secondary or tertiary structure using four sets of appropriately-sized standard aviation grade fasteners.
